Re: Soil Sampling Data Summary Report for  
320 Dove Point, Social Circle, GA  
BBL Project #: 85533

**SAMPLE LOCATION MAP FOR  
 320 DOVE POINT**

Attachment 1  
Photographs of 320 Dove Point Social Circle, GA

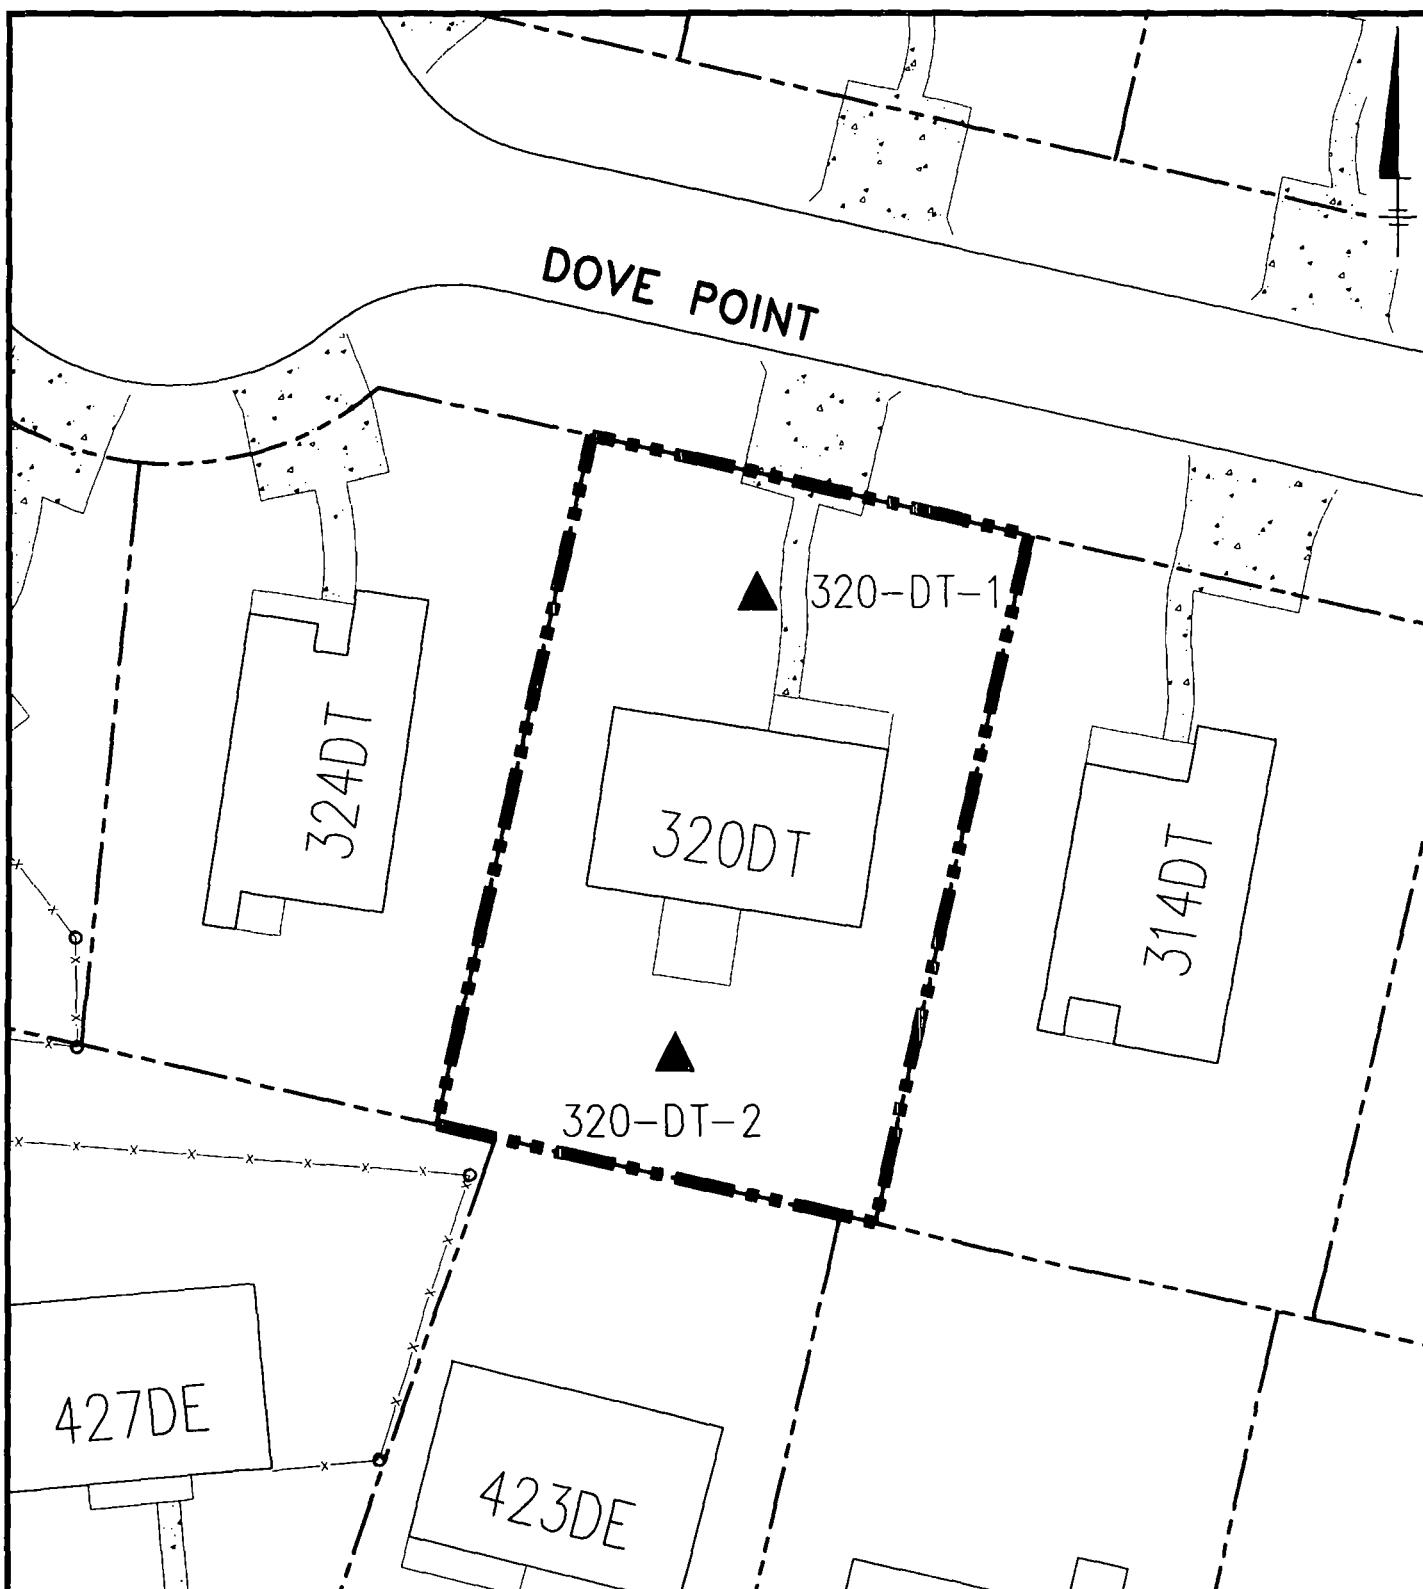
FIGURE  
**320DT**

- Deeper soil samples were collected from one location in the front yard and one location in the back yard. The locations of these deeper soil samples are shown on Figure 1. Samples were collected using hand augers or by pushing hollow steel tubes into the ground to the required sample depth. At each location, soil samples were collected from 0.5 to 2 feet, 2 to 4 feet, 4 to 6 feet, and 6 to 8 feet below ground surface. These samples were tested in the field using the XRF device described above to determine the approximate concentrations of arsenic and lead. Based on these results, select samples were sent to the laboratory and analyzed for metals (including arsenic and lead) and pH (soil acidity).
